# **M**ODERN ENGINEERING AND INNOVATIVE TECHNOLOGIES

## PROTECTION OF THE STATE GEOSITE – “PYVYKHA” MOUNTAIN UNDER THE CONDITIONS OF THE DEVELOPMENT OF SLIDING PROCESSES

**Abstract.** To preserve the state geosite – Pyvykha Mountain, the authors have developed a set of measures to strengthen the landslide slope. However, the work is complicated by the possibility of rockslides and rock collapses, which threatens the equipment and people carrying out strengthening of the shore. After a detailed analysis and generalization of the results of the engineering and geological surveys conducted in this area, the most landslide-hazard zones of the slopes were selected and the stress-strain state of the slope was studied with the help of the Plaxis software complex, considering the possibility of a landslide. According to the simulation results, dangerous zones have been determined within which soil collapses are possible. It was concluded that the presence of people and equipment in these areas should be limited as much as possible.

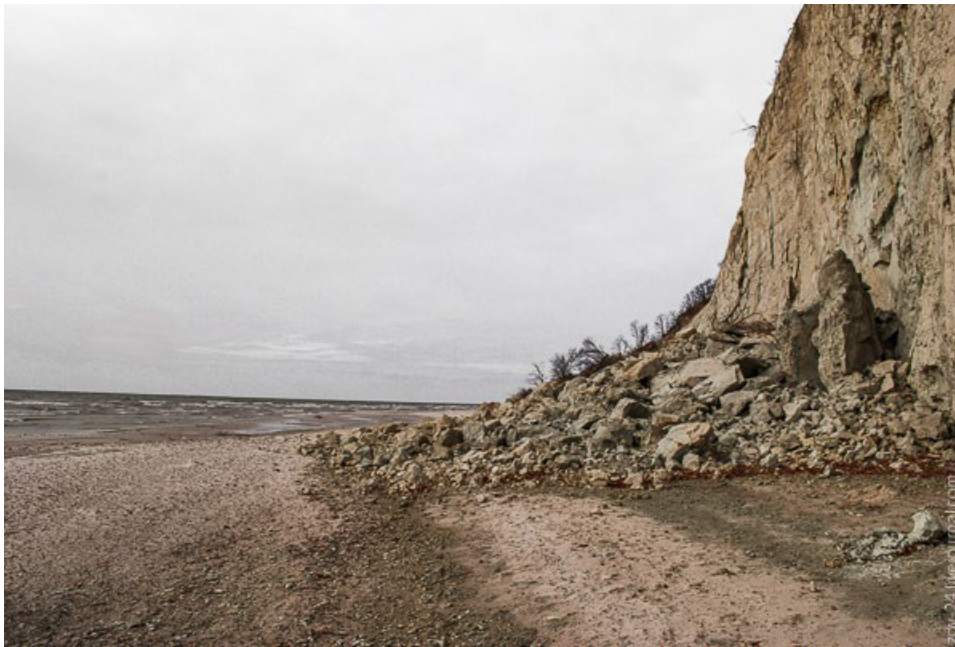
In the process of the reconnaissance survey of the slope section, its condition was visually established. The photo (Figure 3) clearly shows that the slope is sliding, which is evidenced by numerous cuts, and local divisions of individual soil pillars. At the foot of the slope, there are massive blocks of destruction products that have not yet been washed away by water. This confirms the continuity of the slope destruction process and, as a result, the great danger for people and construction equipment, who can be in the action area of the landslide.

**Figure 3 - Landslide processes in the form of landslides-collapses of rock blocks**

2. In the process of reconnaissance survey of the slope section, it was visually established that it should be classified according to DBN B.1.1-46:2017 as a sliding slope. This is evidenced by numerous cuts and local separations of individual soil pillars. At the foot of the slope, there are massive blocks of alteration products that have not yet been washed away by water, this confirms the continuity of the process of destruction of the slope and, as a result, the great danger for people and construction equipment in the area of action of the landslide.
