RESEARCH OF WEAR RESISTANCE OF BRONZE BUSHINGS DURING PLASTIC VIBRATION DEFORMATION

A. Kelemesh, O. Gorbenko, A. Dudnikov, I. Dudnikov

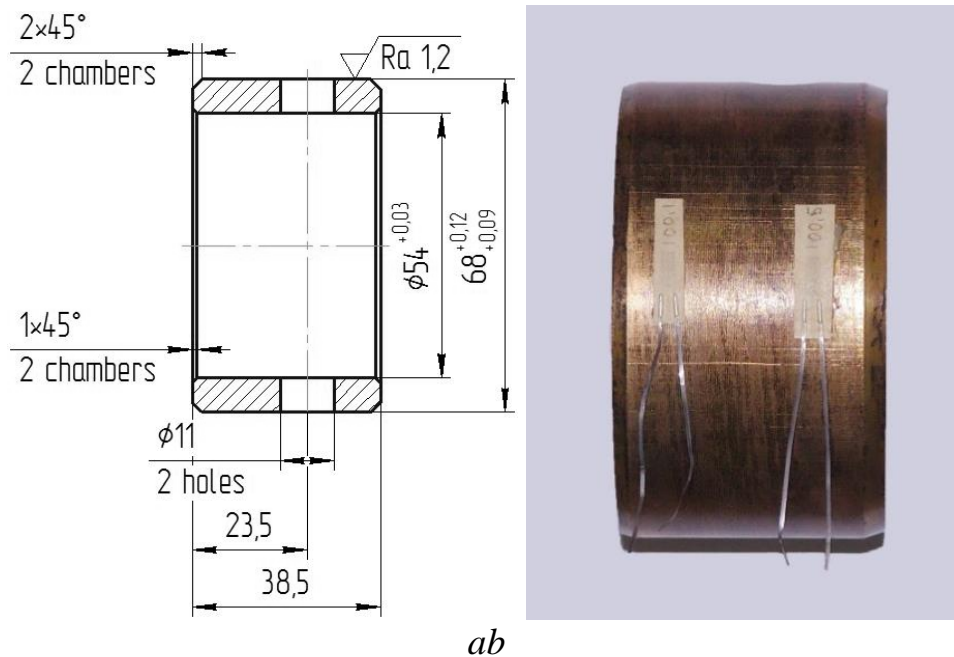
The specimens are made of BrOTsS 5-5-5 bronze (Fig. 1) of two dimensional groups: the first – $L=38.5$ mm; $d=68$ mm; $d_0=54$ mm; the second – $L=30$ mm; $d=68$ mm; $d_0=54$ mm.

Fig. 1. Test specimens: *a* – specimen designs; *b* – specimens of camshaft bushings of YaMZ-236 engines with strain gauges

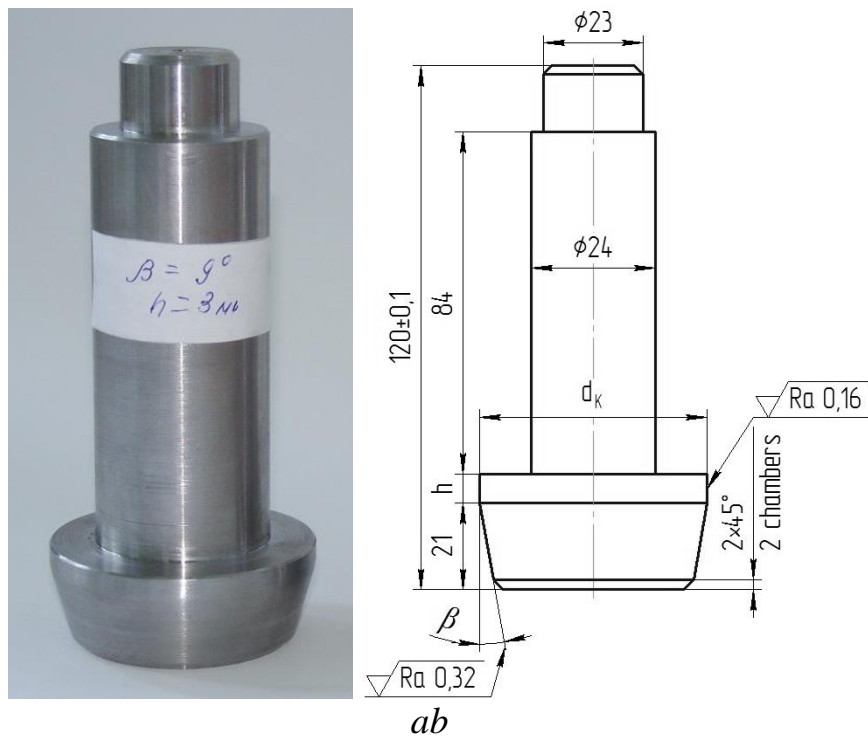
The punches (Fig. 2) were subjected to oil quenching to a temperature of 780–800 °C, tempering at a temperature of 400–420 °C, ageing for 15–20 min, and cooling. The hardness of the working part of the punch was 55–58 HRC, and of the shank – 40–45 HRC. For determining the optimum angle of the treatment tool (punch) during normal and vibration deformation of bronze bushing specimens, the experimental research was conducted with the following angles β : 8°, 9°, 10°.

Fig. 2. Hole punches: *a* – a general view; *b* – a structural diagram

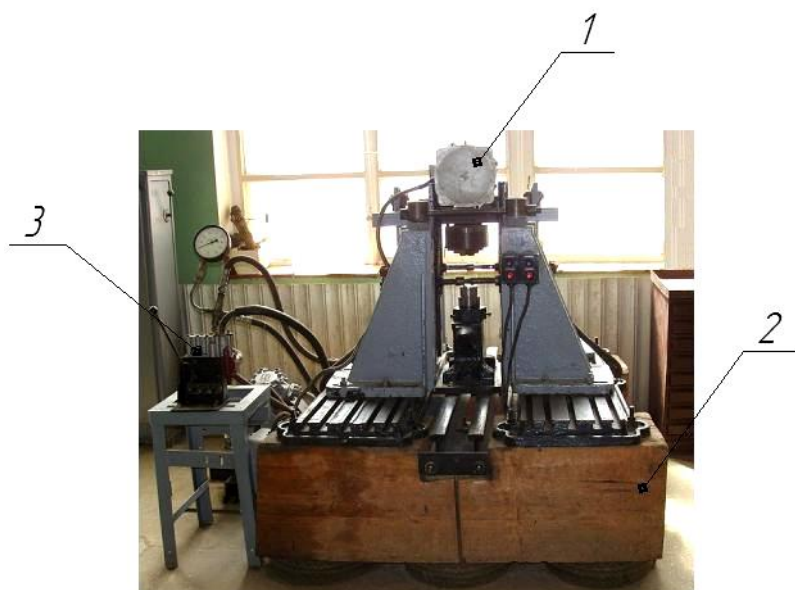
The experimental research of deformation of bushing specimens and parts by the method of vibration deformation was carried out on an installation, whose general view is shown in Fig. 3. The main units of the installation are a vibration exciter (1), a base (2) and a hydraulic lifting system (3). The bed and auxiliaries provide attachment of the vibration unit, and also create reliable isolation of the entire installation from the floor.

Fig. 3. The general view of vibration installation: 1 – a vibration exciter; 2 – a base; 3 – a hydraulic lifting system

Vibration installation allows performing such operations as distribution, compression and hardening. The required operating parameters are set on the installation using the vibration unit. The operating parameters include the vibration amplitude and frequency, as well as the speed of the treatment tool.

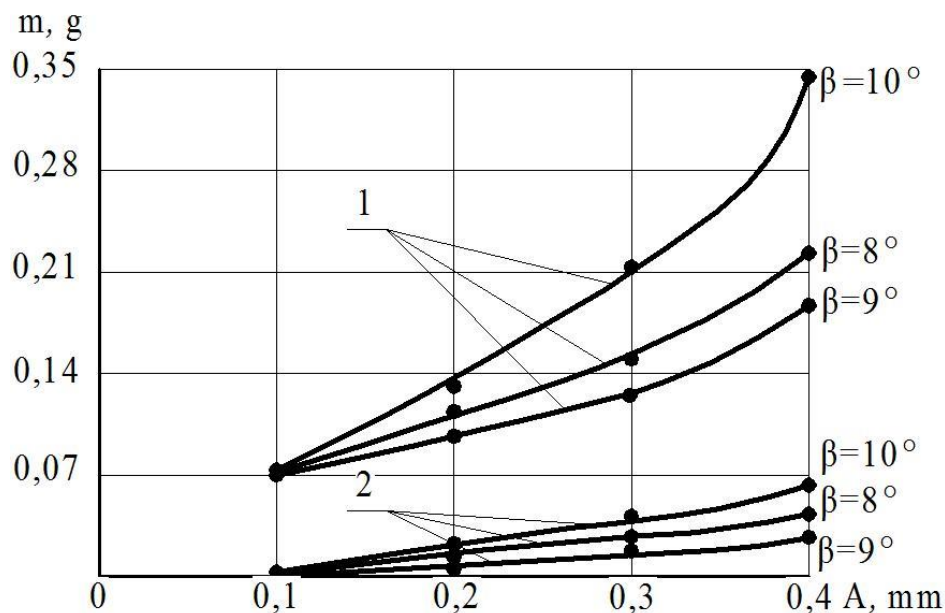
The values of the metal shifted to the specimen ends at different punch angles and deformation rate of 0.03 m/s are shown in Fig. 4.

Fig. 4. Variation of the mass m of the metal shifted to the bushing end at different punch angles β : 1 – normal deformation; 2 – vibration deformation

The research found that the smallest amount of the shifted metal was at the punch angle $\beta=9^\circ$. Under vibration deformation, the intensity of the metal shifting to the end of the bronze bushing with a length $L=38.5$ mm is much lower compared to normal distribution. Thus, at the punch angle $\beta=9^\circ$ and allowance $A=0.4$ mm, the mass of the shifted metal under vibration deformation is 6.5 times smaller in comparison with normal distribution.

Under normal deformation, the variation of the amount of the metal shifted to the bushing end is non-linear within the allowances $P=0.1...0.4$ mm, and under vibration deformation – almost rectilinear. The smallest amount of the material shifted to the specimen end during deformation was at the punch angle $\beta=9^\circ$. This is due to the fact that at smaller angles, the contacting surface of the punch with the treated bushing increases. Consequently, the number of contact points increases, thereby increasing the material adhesion. With an increase in the punch angle, the contact surface decreases, thus increasing the specific pressure and the amount of the adhered material.

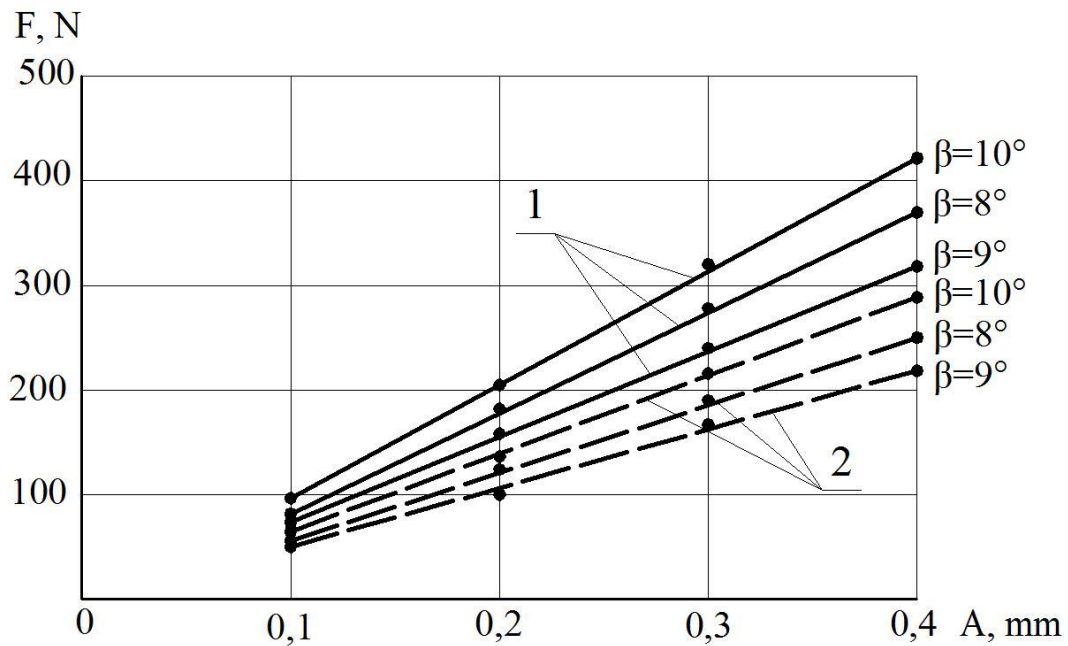
In the course of the research, the deformation forces were determined by means of a pressure gauge and strain gauges. Fig. 5 shows the graphical dependencies of variation in deformation forces of specimens for different allowances under normal and vibration deformation.

Fig. 5. Variation of deformation forces F from the punch angle β : 1 – normal deformation; 2 – vibration deformation

As can be seen from Fig. 5, with increasing the machining allowance and the punch angle, deformation forces increase both under normal and vibration loading. The nature of the curves is identical. The variation of the deformation force of the BrOTsS 5-5-5 bronze specimens with the machining allowance $A=0.4$ mm and the punch angle $\beta=9^\circ$ is 1.15 and 1.33 times lower than at the angles $\beta=8^\circ$ and $\beta=9^\circ$, respectively.

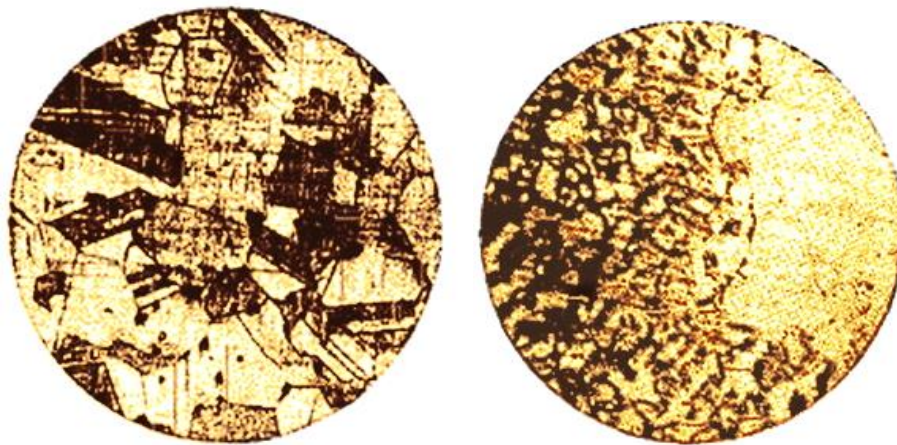
Fig. 6 shows the microstructure of specimens after normal and vibration deformation.

The microstructure examination showed that vibration deformation provides a more fine-grained and uniform structure in comparison with normal treatment.

Fig. 6. Microstructure of BrOTsS 5-5-5 bronze specimens at $\times 100$ magnification: *a* – normal deformation; *b* – vibration deformation

The research has shown that vibration loading leads to an alignment of the structure. It becomes more uniform and fine-grained. Under deformation, more fine
